Case Study

Permanent Network Monitoring Managing Water Loss

Bluffton, IN

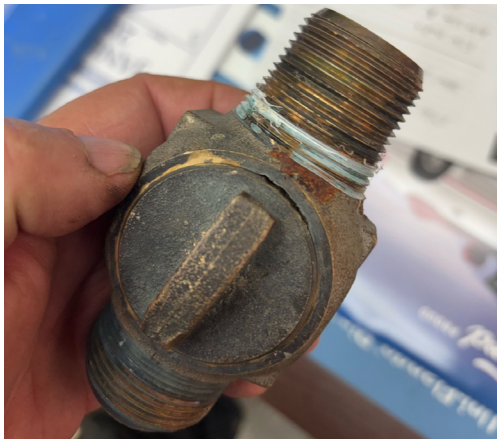
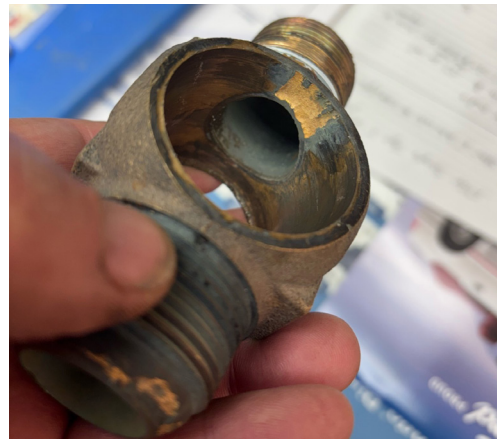
Photo of the damaged curb stop body.

"When they dug up the tap on SR 124, we noticed that the curb stop body went bad. With it leaking so bad it ruined the threads in the main and we had to put on a tapping repair clamp."

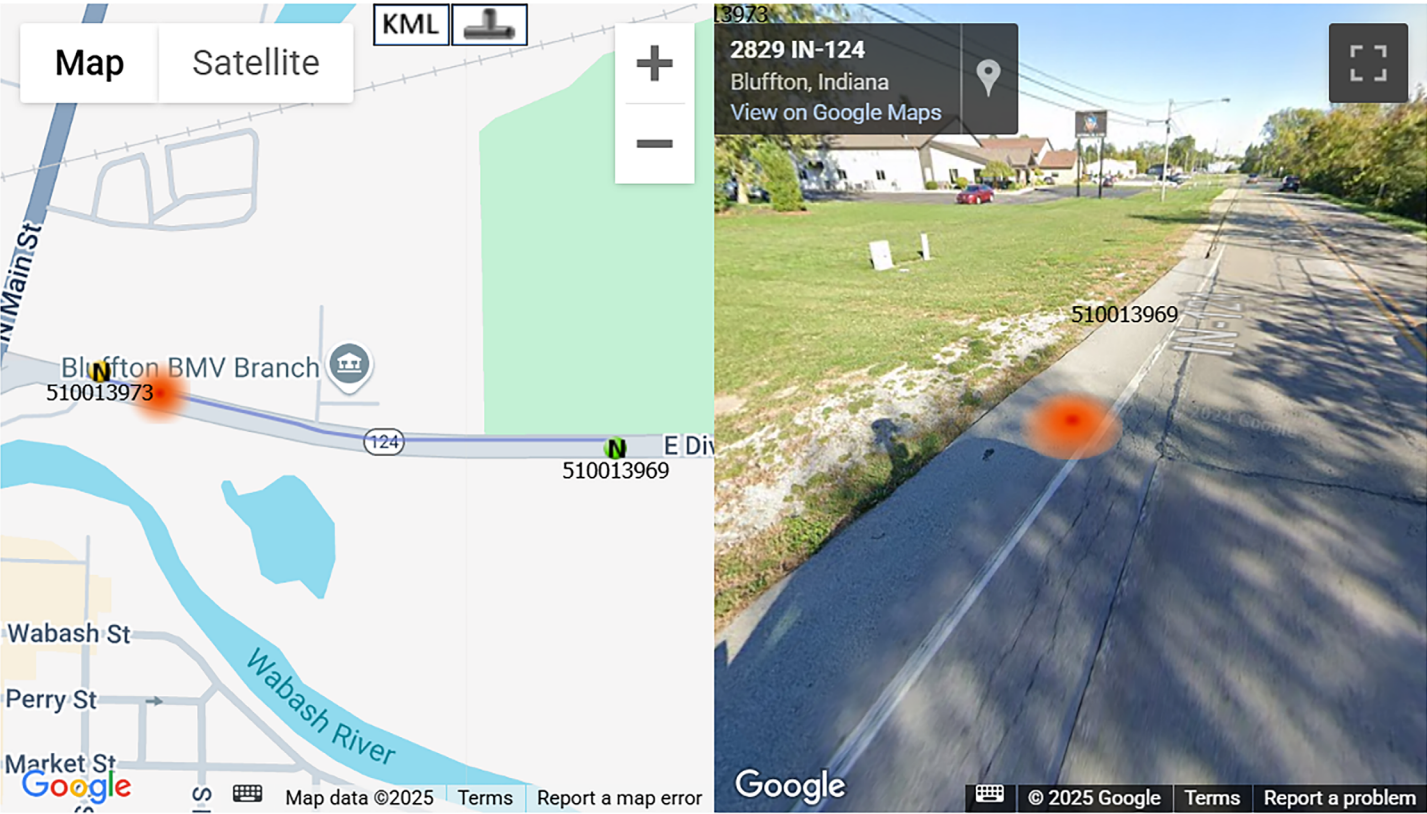
Correlation: 510013969 - 510013973

Quality	Location	Logger 1	Logger 2	Dist. L1	Dist. L2	Center Dist.	Pipe Len.	Comments
100.0	2745 E Sr 123, 40.742832° -85.169336°	510013969	510013973	1,362.8 ft	222.4 ft	570.2 ft	1,585.2 ft

The pipe between the loggers had sections of 12” & 16” Diameter Ductile Iron and the total pipe length was 1,585.2ft.
