Case Study

Permanent Network Monitoring Managing Water Loss

Bluffton, IN

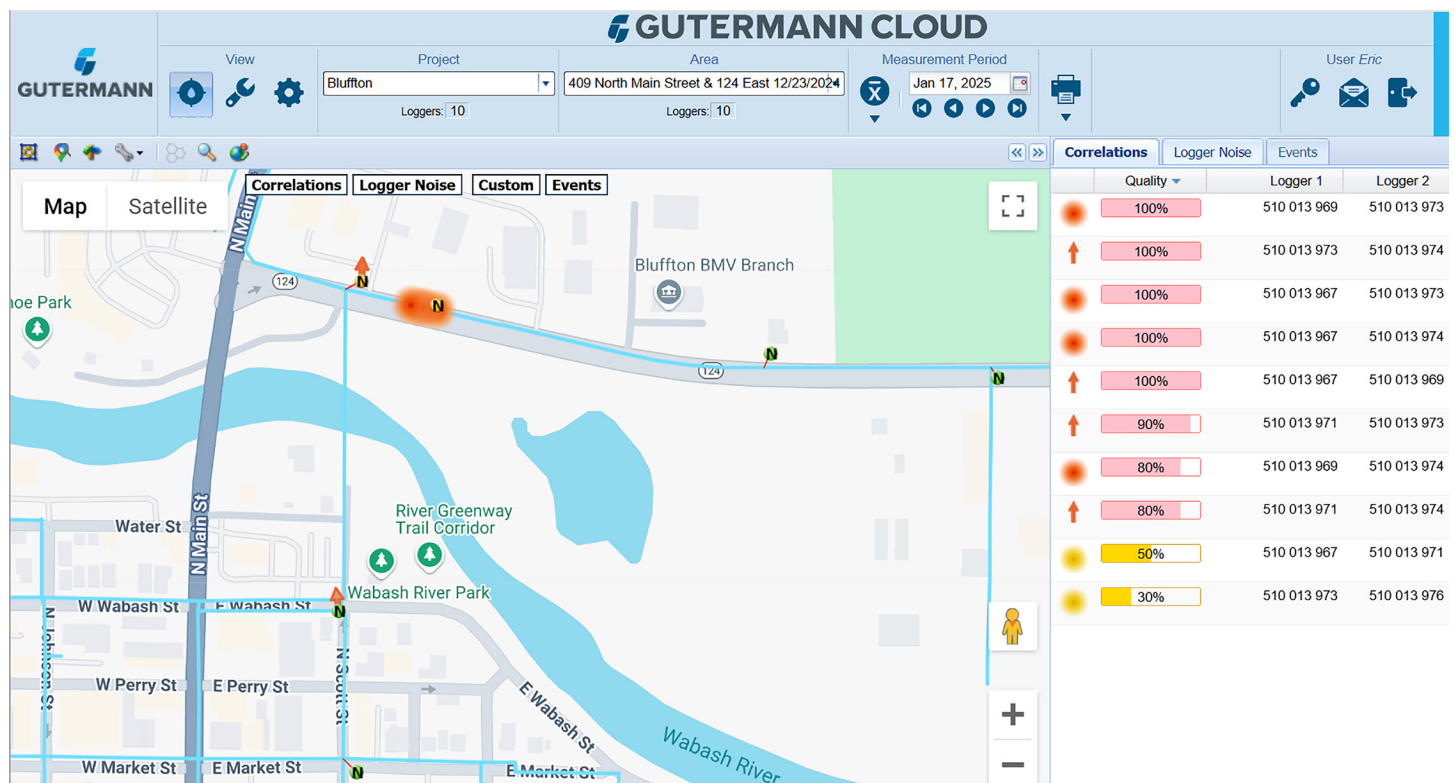
The Gutermaann Cloud compares all data and will automatically display a Correlation “blister” if a potential leak is in between two loggers OR a “single arrow” if the potential leak is outside two loggers. This means that two loggers are hearing a similar leak frequency.

It is then the leak technician's responsibility to further investigate and determine if a leak or no leak is present. This is typically completed with an Acoustic Ground Microphone.

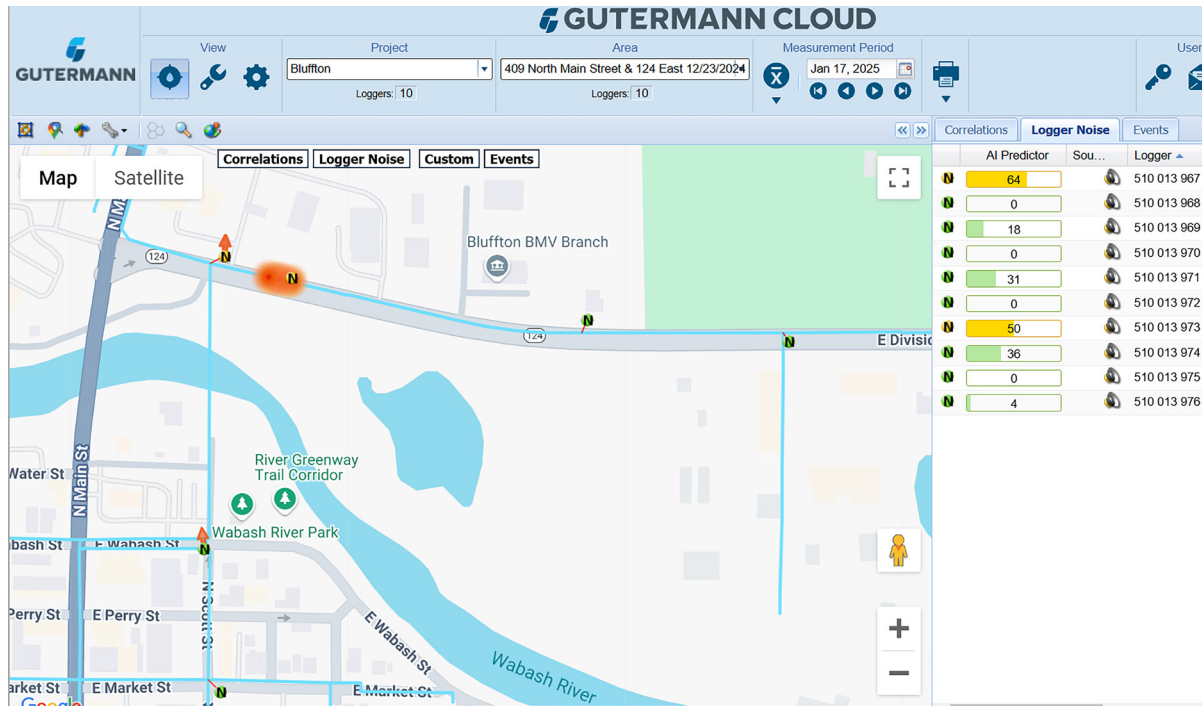
In addition to the Correlation, the Gutermaann Cloud will also provide each logger with a "leak score." The leak score is based on a numbering system of 0-100. 0 being quiet and 100 very loud. The difference in color is preset as follows. Below 40, green / below 80, yellow / 100 and below, red.

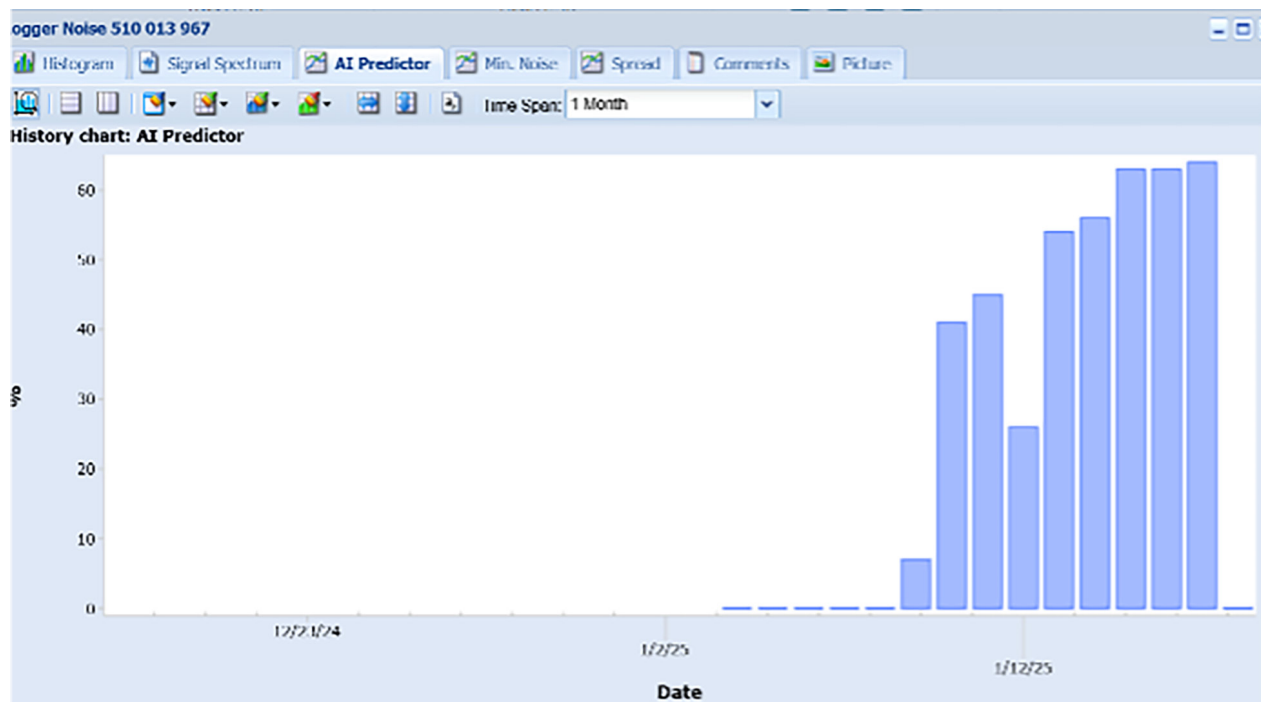
HISTORICAL DATA:

Leak Score History can be viewed over different periods as shown below. Tracking leak run times and trending information.

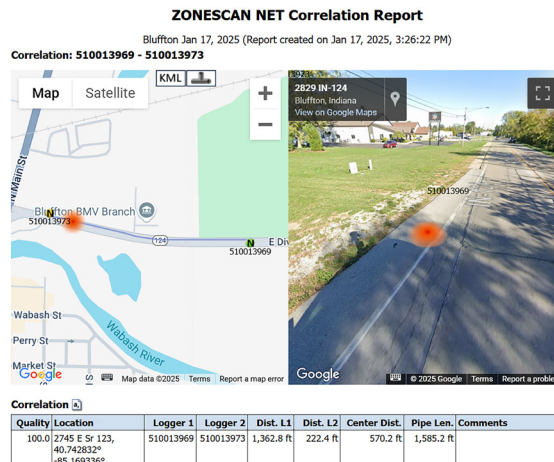
Correlation Report:
Provides a distance to
the leak from each
logger.
